<b>Hot Works IncidentALERT TOPIC</b>	Hot Works Incident	<b>ALERT REFERENCE:</b>	Hot work
<b>TARGET AUDIENCE:</b>	CRL and relevant Stakeholders	<b>AUTHORISED BY:</b>	N Roper
<b>DATE OF ISSUE:</b>	Tuesday 19 April 2022	<b>DISPLAY UNTIL:</b>	Sept 2022

## INTRODUCTION

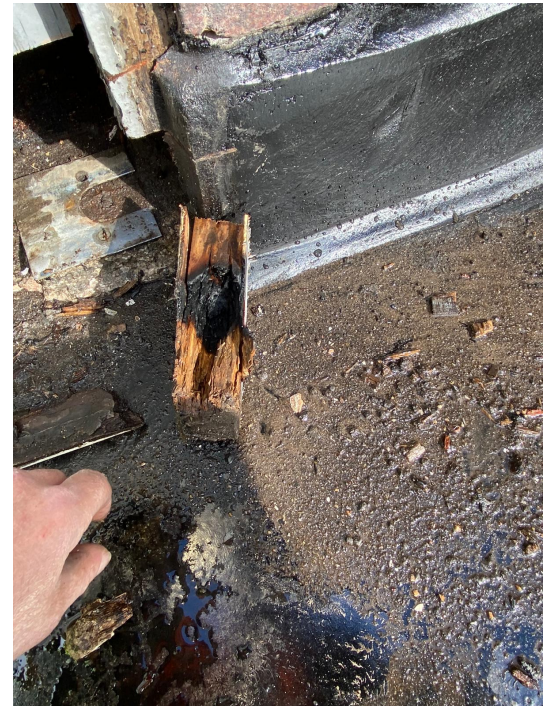
- The fire brigade identified a hot area and cut out a section of the door that had commenced smouldering and was producing smoke.
- There was no sign of heat or smoke on the external face of the door.
- Air was being drawn into the building under the door, preventing smoke being seen externally.
- The door had not been opened to check if any flammable materials were stored inside adjacent to the door.
- The CRL Hot Work Permit required combustible materials to be removed or protected – the door hadn't been identified as a risk.

- There was a failure to identify the potential fire risk of the wooden door within the task specific risk assessment.
- The Point of Work Risk Assessment should have identified the risk.
- The CRL Hot Works Permit has been revised and can be found on the Centura Intranet Homepage – Files – Document Link – Search Hot Work Permit
- The asphaltting contractor is revising their procedures to recognise other potential flammables when carrying out their works.
- Where flammable items cannot be removed e.g. doors, they should be opened to ensure they are not affected by the Hot Works.
- Where there is a risk of flammable materials on the inside of a structure that could be affected by Hot Works e.g. carpets, storage boxes, they must be identified and managed prior to the works.
